# FACILITY COMPLIANCE AUDIT REPORT

**Date of Audit:** 15 February 2011

Miller Farm LCID Landfill Miller Farm Road Morehead City, NC 28557

N0190, 021511

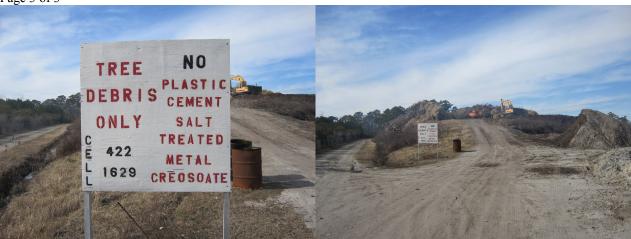
Proper signage posted at the landfill entrance

Landfill access; note signage, trash receptacles, and soil stockpile

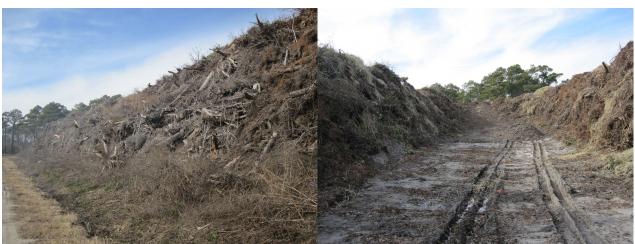
- 9) All the landfill sideslopes have not been covered adequately and graded to promote positive drainage of surface waters.\*Within thirty days of receipt of this audit report, please compact, cover and grade all sideslopes at a slope of not greater that 3:1. All covered and graded areas should then be seeded and mulched to establish a groundcover suitable to prevent erosion of the landfill cap.

Sideslope needing cover

Working area needing cover and grading
